Asbestos Management Plan

Abbey Primary School

Willow Learning Trust

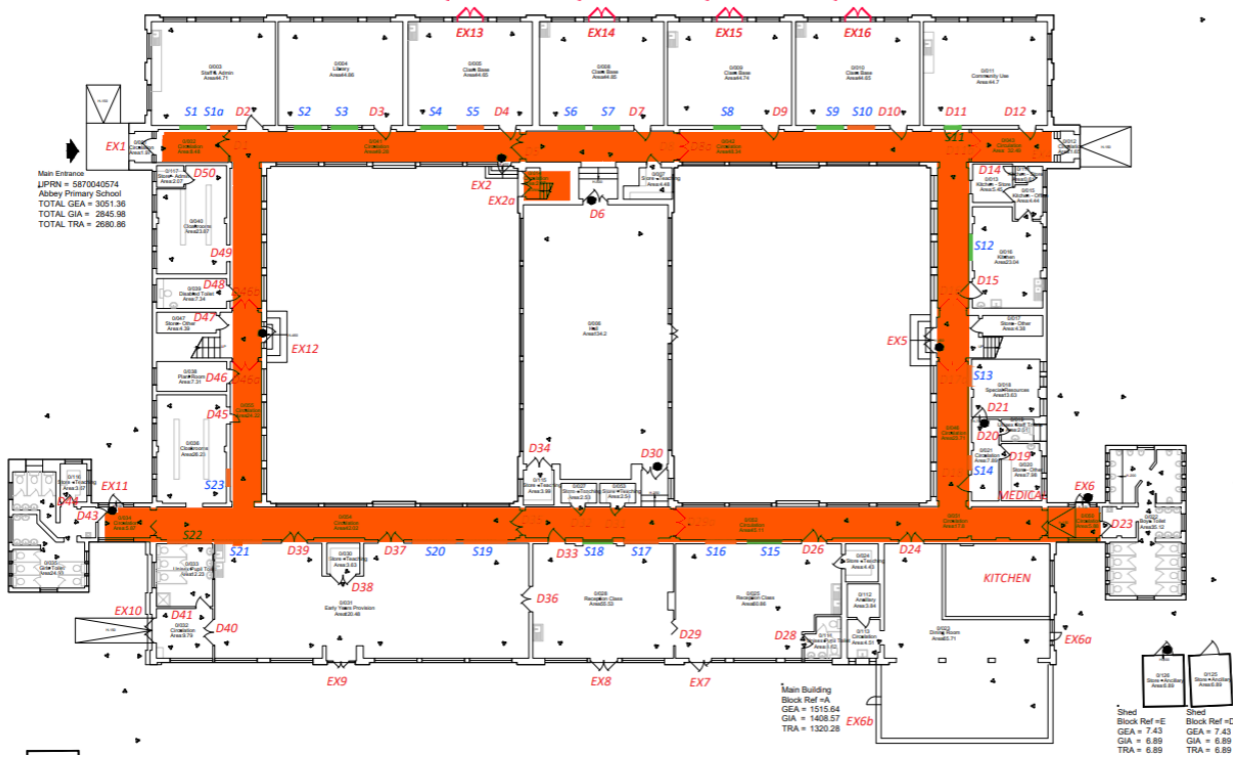
Presumed asbestos in the pipe lagging under the corridors on ground/first floor.

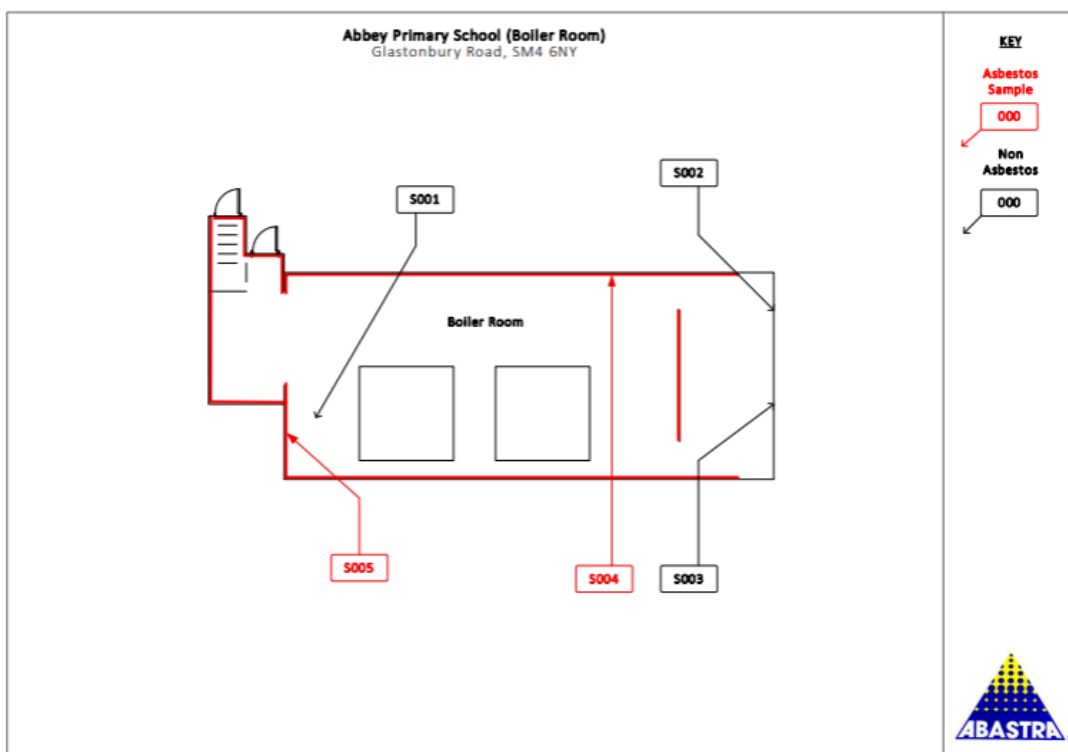
Appendix 3 – Survey Drawings

Abastra Environmental Limited
PR6885 - Abbey Primary School (Boiler Room)
